A Case History of Microtunneling through a Very Soft Soil Condition

the Contractor's Perspective

Abstract- Waikiki Public Bath Force Main Replacement Project consists of 1,037 m of 400 mm force main that carries the wastewater from the Public Bath pump station to a gravity sewer on the Kuhio Avenue. This force main transports wastewater underneath Kalakaua Ave, very close to some of the most expensive real state in the world. This area is the heart of Waikiki beach, and it is full of beach resorts, five star hotels, shopping, etc. The soil strata can be described as 2.50 to 3.00 m deep of beach sand on top of half a meter of a very hard coral ledge on top of a lagoon deposit layer (very soft gray fat clay). The N_{SPT} values in this lagoon deposit layer range from zero to eight. The specified construction method for this project was microtunneling of 700 mm of Permalok steel casing with a 400 mm PVC carrier pipe inside the casing. The annular space between the two pipes was grouted with low density grout. Many problems were encountered during the construction phase of this project. This paper is a retrospective review of the project from the contractor's point of view. It covers

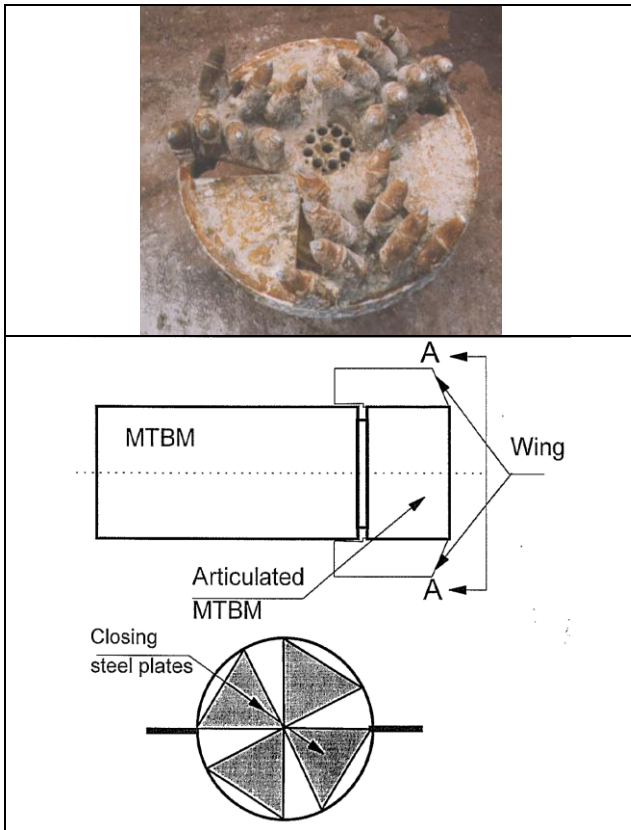
Figure 3 Wings modifications and choking the entrance of the MTBM

1. Welding two plates along the sides of the articulated head as shown in Figure 3 to reduce the stress on the soil. The front edges of the plates would be serrated so it can cut through the coral if encountered.

2. Choking the entrance to the crushing chamber as shown in Figure 3 and stop running the tunneling system.

The estimated cost for the MTBM rework amounted to approximately \$8,500. There were other related miscellaneous cost (rubber ring, larger exit and entry rings, dewatering, etc.) making the total cost about \$25,000. In addition, the estimated cost for the machine retrieval amounted to about \$35,000 excluding the cost of retrieving the head in case of failure. This solution could be executed by the contractor without the need for subcontract from outside Oahu, which would reduce the delay in completing the project. This solution had never been tried before. There was also the potential risk of encountering coral along the path of the wings.

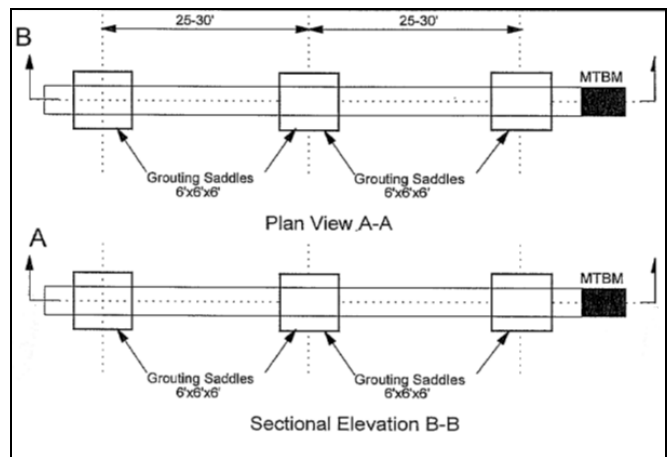
Figure 4 Compaction Grout Saddles Solution

The microtunneling machine would tunnel through the upper meter of the saddle as shown in Figure 4. It would go from cube to cube without falling substantially off grade. As the MTBM tunnels through the grout block, the microtunneling machine operator would steer the head against the harder body underneath it and correct the grade. The quoted cost from the grouting subcontractor was \$100,000; the total cost was estimated to be \$125,000 after adding the cost of the machine retrieval.

The grout would be injected as a homogeneous mass with a distinct interface between the grout and soil. It would move into the weakest zones creating an irregularly shaped matrix of soil. Advantages were minimum site disturbance and risk, flexibility of scope, economy, applicability where the groundwater surface is high, and ability to lift settled structures to proper grade ^[7]. Compaction grouting is a proven method of stabilizing fine grain soils, but it has experienced a mixed history; technical success and cost control remain difficult to predict. It depends mainly on the permeability of the ground requiring stabilization ^[8]. The associated risks with this solution were the settlement and stability of the block, inconsistency of the block material, location, dimension, and permeability. It was uncertain if the 1.5 m length to the grouted block would be sufficient to correct the grade. Additional disadvantages were: limited number of suppliers, a long waiting time to procure a contract and to transport the required equipment to the Oahu, the risk of over spilling on the streets and sidewalks, which was not acceptable in Waikiki, and the experimental nature of the compaction grout in that microtunneling application.

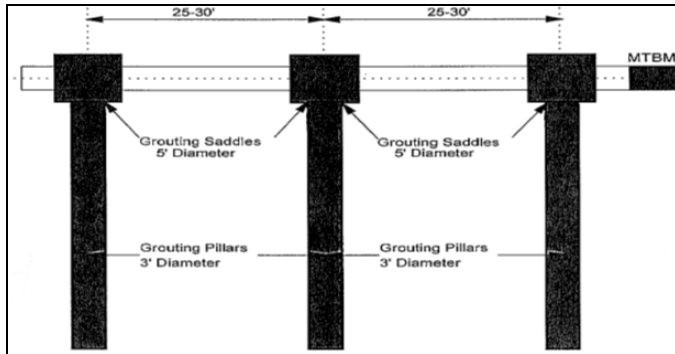
Figure 5 Compaction grout pillars solution

D. Compaction grout pillars solution would involve grouting 750 to 900 mm diameter pillars extending upward from the harder layer at the bottom up to one foot below the invert of the casing pipe as shown in Figure 5. The pillars would support grouted cubes similar to the grout cubes of the previously mentioned solution. The pillars and the cubes would be constructed using compaction grout. The spacing

of the pillars would be 7.5 to 10 m. The quoted cost from the grouting subcontractor was \$140,000. This solution provides more stability to the saddle by carrying the weight of the saddle and the head to a more stable soil through the pillars. The disadvantages were inconsistency of the block material, inaccuracy of the block location, dimension, and permeability, and sufficiency of the 1.5 m length to correct the grade. This solution also has never been tried before.

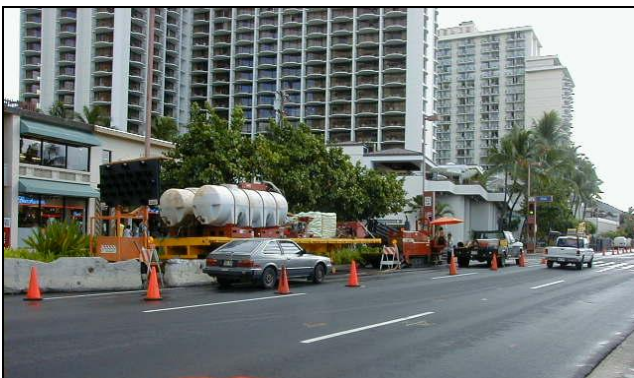
Figure 8 Minimum impact of HDD operations on the businesses, hotels, and traffic

During that year, the contractor, engineer, construction manager, and the owner decided to abandon microtunneling as the installation method and install the pipe for the rest of the project using horizontal directional drilling (HDD) without any significant problems and with minimum impact on the businesses, hotels, and traffic as shown in Figure 8.
