Why Was It So Damaging?

The Lorca Earthquake, 2011 May 11th

Atonio D. Aretxabala¹, Cristina L. Sanz²

¹Building Department, School of Architecture, University of Navarre

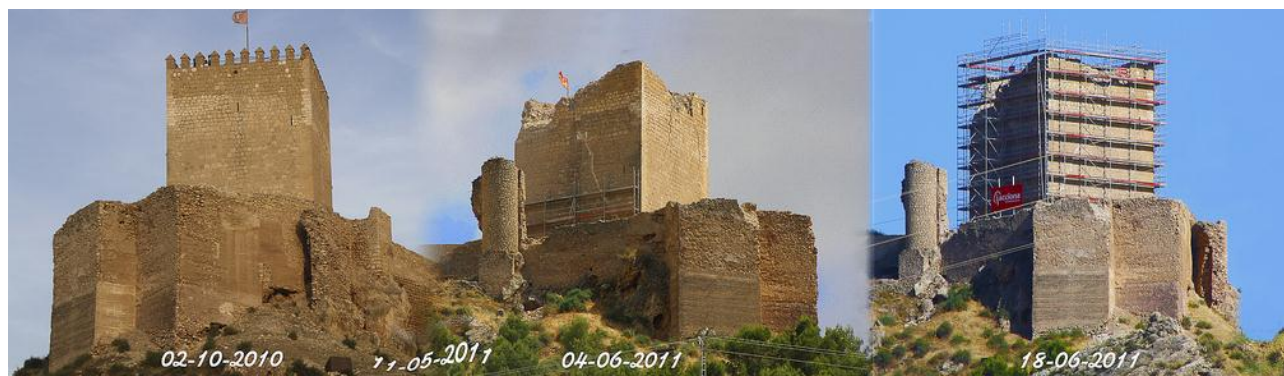
Fig. 2 Espolón Tower of the Castle ensemble, before and after the earthquake (left and centre), and under restoration (right). (Picture: Nandocd, www.flickr.com)

- **Espolón Tower (XIIIth c.) San Antonio Porch, San Clemente Hermitage, medieval walls of the Castle and the National Parador** (public-owned luxurious hotel in historical site), near the synagogue. The Castle is a fortress built throughout Xth and XVIth centuries, declared Protected Cultural Asset in 1931. The Historical Centre of Lorca, including the Castle, was declared a Historical-Artistic Ensemble in 1964. Damage in the tower shows evidence of the main direction of the horizontal shakes, due to the NE location of the epicentre. Most damaged corners are those in the NE-SW diagonal of the plan (Fig. 2).

Final budget: 11,169,293.13 €. In restoration

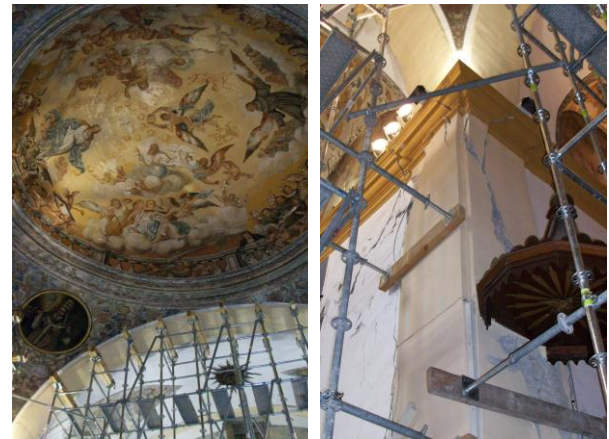
Fig. 4 Inside damage, Convent of the Virgen de Huertas (Authors own archive)

- **Convent of the Virgen de Huertas (XVth c.).** Baroque ensemble, partly rebuilt in the XVIIth century, recently restored (Fig. 4).

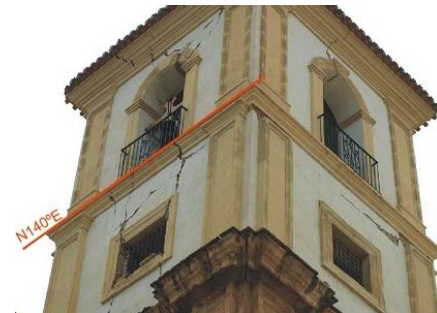
Fig.5 Damaged top of the tower, Church of Santiago (Scheme of the IGME Final Report)

The collapse analysis revealed that restoration works carried out in 1994, reinforcing the masonry structure with too rigid RC elements, did not reduce the structural vulnerability but even increased it, possibly causing the collapse. The bell tower shows also evidence of damage due to rotation (Fig. 5).

Final budget: 2,100,256.00 €. Unrestored.

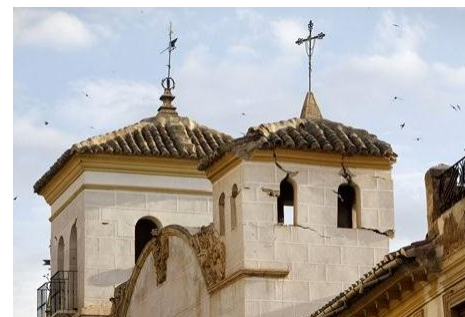
Fig.6 Damaged top of the Santo Domingo's towers, before partial demolition

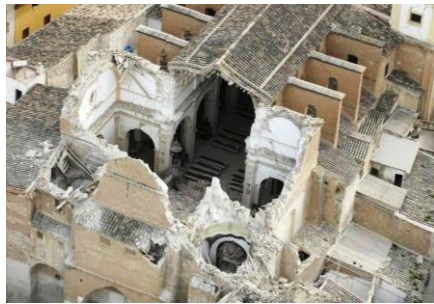
- **Church of Santiago (XVIIIth c.)** Baroque style building, its dome collapsed after the second event (Fig. 7).

Fig.7 Church of Santiago in Lorca (Spain), after dome collapse and similar damage in the Duomo of San Massimo in L'Aquila (Italy) (Photographs: Atlas Agency, 201-05-13 and AP/Alesandra Tarantino, 2009-04-07)

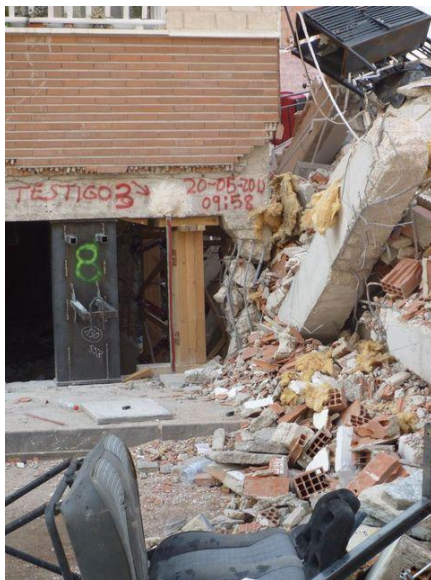
Fig.8 View of the West façade of the dwelling building that collapsed during the earthquake, located in La Viña Square

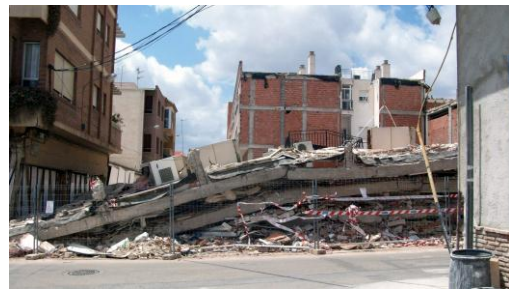
Fig.10 View from the main façade of the building that completely collapsed after the second event (Southern side)

A three story multi-dwelling building with ordinary moment frame RC structure collapsed after the second shock, because of the incorrect configuration of the basement columns.

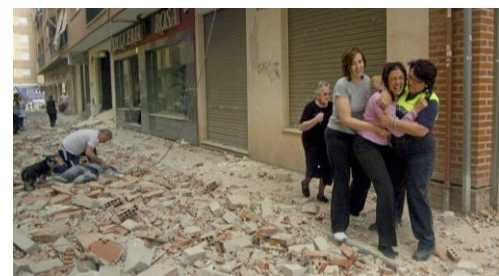
Fig.9 One of the victims, under debris (Photograph: Globovisión)

All of the victims were killed in the streets, by falling façades or non-structural construction elements broken loose from buildings. Roof and others parapets fell because of the inertial or shaking horizontal forces on the elements themselves (Fig. 9).

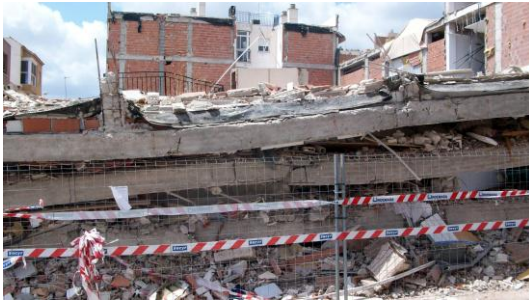
Fig.11 View from the central area of the main façade of the same collapsed building of the former Figure.

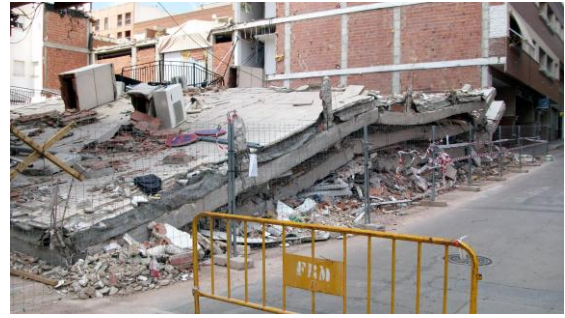
Fig.13 View from the main street of the building collapsed (north part)

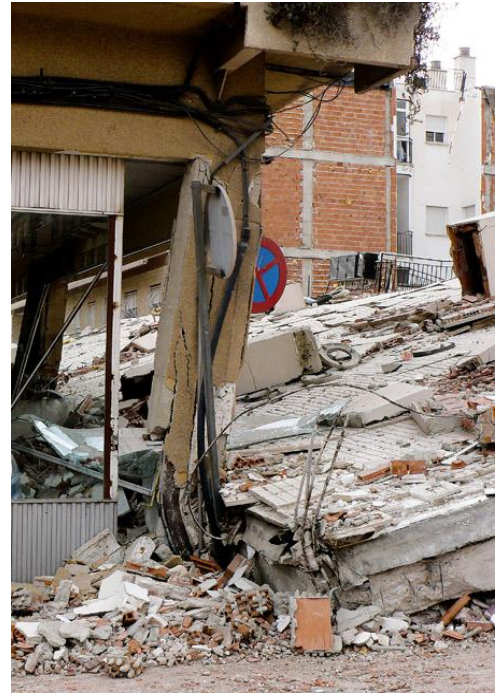
Fig.14 Irregular and not uniform distribution of masses, stiffness and ductility, combined with inexistence of masonry under first floor spans and different height of columns (soft story)

The inexistence of a sufficient gap between masonry and the columns restrains their free movement, causing the damage.

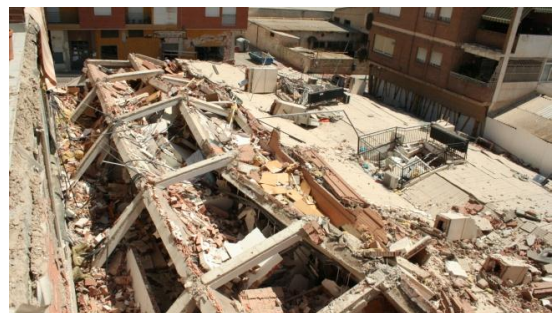
Fig.15 Aerial view of the building that collapsed (detail of the north part)

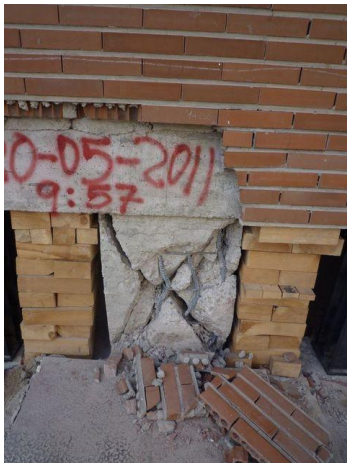
Fig. 16 Short column that did not collapse

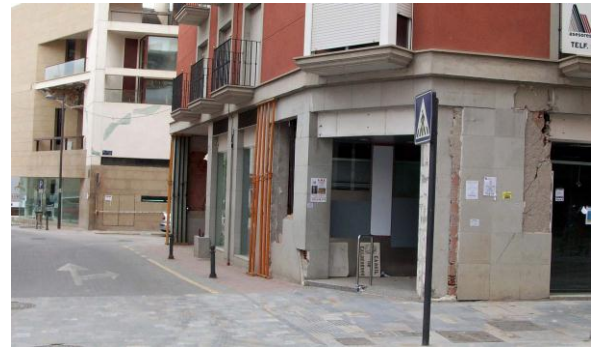
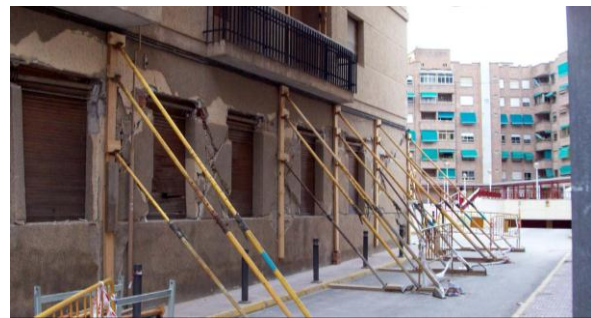
Masonry walls in direct contact with ground floor columns suffer an undesirable short storey effect, increasing the shear demand in columns accordingly, causing severe damage (Fig. 18).

Fig. 18 Soft-story damage and scheme (P. Murphy) and induced short column by masonry walls (A. Aretxabala)

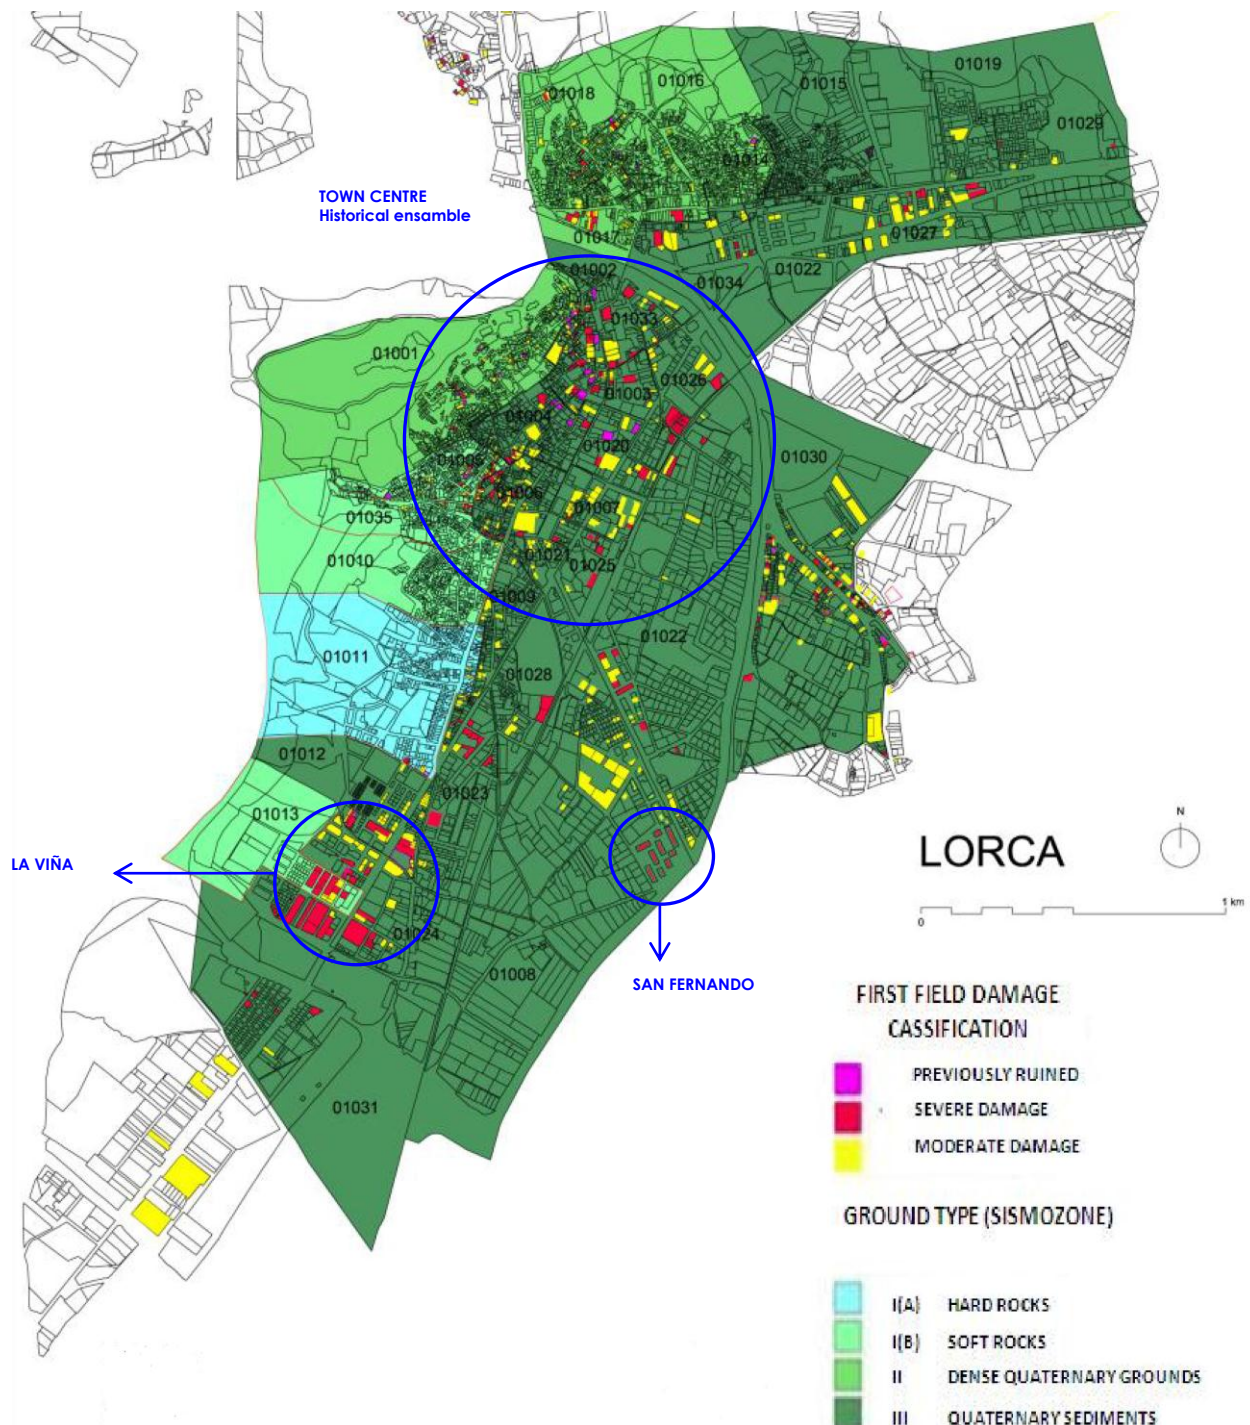
Fig. 21 Lorca first field damage classification and ground type (IGN, INFORME DEL SISMO DE LORCA DEL 11 DE MAYO DE 2011)

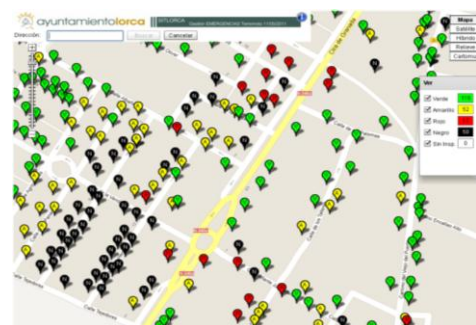
Fig. 22 La Viña district building damage, Lorca's Town Hall Visor

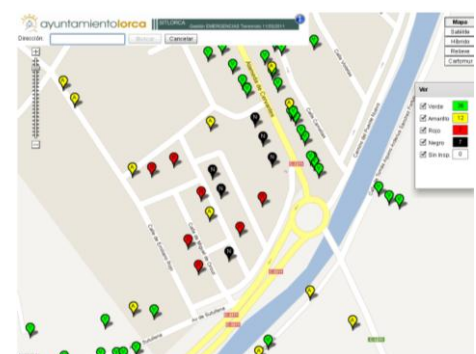
Fig. 23 San Fernando district building damage, Lorca's Town Hall Visor
