# On Site Monitoring of Corrosion of Marine Structure Using Self Sacrificial Galvanic Anodes – Case Study

This paper reviews the performance of the anodes installed in two marine structures rehabilitated using the sacrificial anodes, one at the main land in Chennai, Southern part of India, and the other at a highly corrosive environmental zone Andaman and Nicobar Islands, India. The repaired area remained intact with no signs of deterioration or formation of incipient anodes around the periphery. The results show that the anodes continue to deliver a significant current. This paper explains in detail about the usage of sacrificial anodes, which can postpone corrosion in rehabilitated concrete structures.

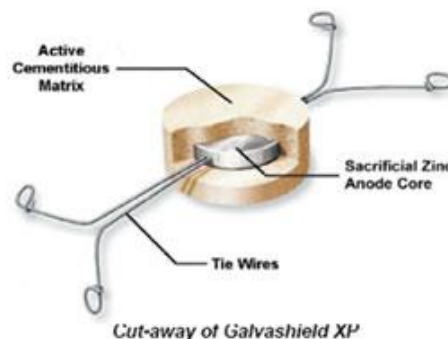
The heart of the device is a metallic anode composed of zinc, which is cast around a pair of steel tie wires. This unit is encased within a cementitious shell. The device is shaped like a short cylinder, about 2.5 inches in diameter and 1 inch thick. The tie wires extend out on the opposing sides of the anode to enable it to be tied to the reinforcing steel. Fig. 2 shows the typical view of different galvanic anodes being used in the repair and rehabilitation of RC structures, and shows a cut-away view of a sacrificial galvanic anode.

Fig. 2 Cut away section of anode

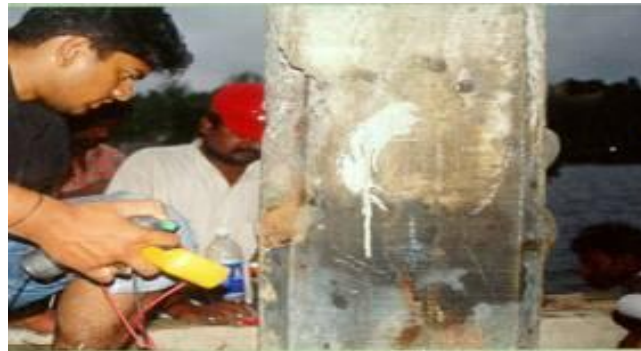
The half cell potential survey was conducted before taking up the work. This method covers the estimation of electrical half cell potential of reinforcing steel in concrete, for the purpose of determining the corrosion activity of the reinforcing steel. Fig. 3 shows the typical view of half cell potential reading being taken on site.

As a copper-copper sulphate ( $\text{Cu-CuSO}_4$ ) electrode (reference electrode), half cell is used in this test. It consists of rigid tube of electric material that is non reactive with copper or copper sulphate, a porous wooden plug that remains wet by capillary reaction and a copper rod that is immersed within the tube in a saturated solution of copper sulphate. The solution was prepared with reagent grade copper sulphate crystals dissolved in distilled water. The solution was considered super saturated when an excess of crystal (undissolved) lies at the bottom of the solution.

Fig. 3 Typical view of onsite measurement of half cell test

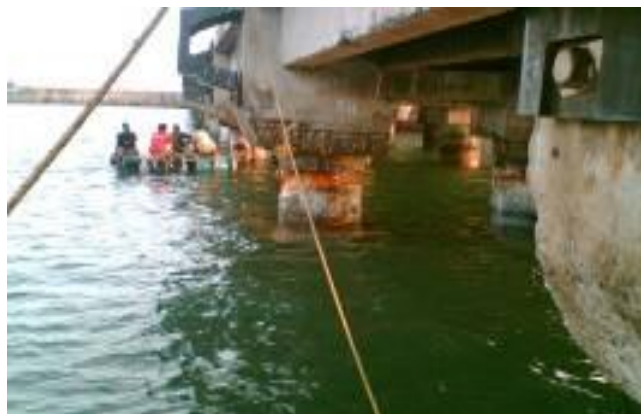
Fig. 4 Typical view of corroded member - Case 1

As the concrete would have got contaminated with chloride, these chipped of surfaces were cleaned by flooding potable water using high pressure water jet equipments. The exposed rebars were also cleaned with high pressure water jet and also by means of mechanical cleaning where ever required. The existing corroded rebars were coated with zinc based protective coating. As the section needs to be increased to take care of the loading in the Case 1 and the corroded rebar diameter were reduced more than 50% in Case 2, shear connectors were provided at every 500mm c/c on the faces of piles and pile caps in staggered manner. The holes were washed well and shear connectors were anchored using polyester resin. The additional reinforcement was tied and also welded at a few places to the shear connectors so that the connectivity in the structure is ensured.

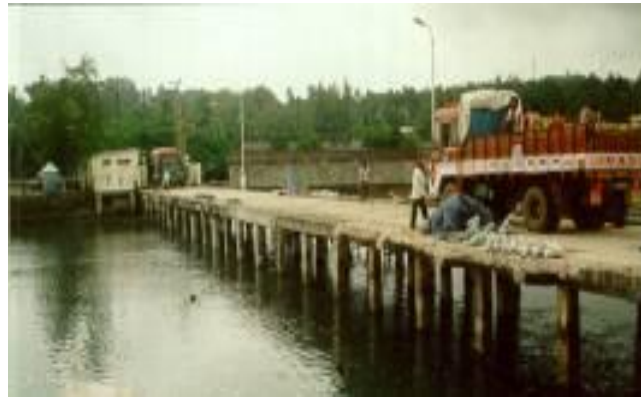
Fig. 5 Typical view of corroded member - Case 2

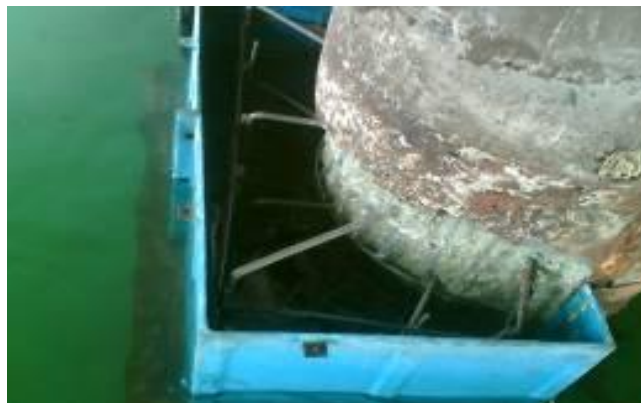
The form work for the required size & shape was kept ready and a trial was conducted before fixing the same for the micro concreting. This was done at every pile/column so that when the epoxy jointing compound was applied to the form work, the micro concrete can be completed well within the tacky stage or otherwise this would act as a debonding layer. Fig. 6 shows the typical view of the epoxy jointing compound with the sacrificial anode installation in the case study 1.

Fig. 6 View of additional rebars, poxy &amp; rnode installed

Two component epoxy resin jointing compounds were applied, since the chloride ions were expected to be in core concrete and this membrane would arrest the ingress of chloride ion from the core concrete to the newly laid micro concrete and also act as jointing compound. The self regulating galvanic anode Galvashield XP is an amphoteric zinc block embedded within specially formulated cementitious mortar having a pore solution pH which is sufficiently high for corrosion of the anode to occur. Galvashield XP was positioned to ensure all round contact with the reinstatement material and attached to the reinforcement using the wire ties. Tightening of the wire ties was carried out using the Galvashield Fixing Tool so that no free movement is possible, thus ensuring the electrical continuity. To test electrical continuity between wire ties and reinforcement bar continuity meter, a voltmeter was used. Fig. 7 shows the closer look of the installed self sacrificing Galvanic anodes in the case study 2.

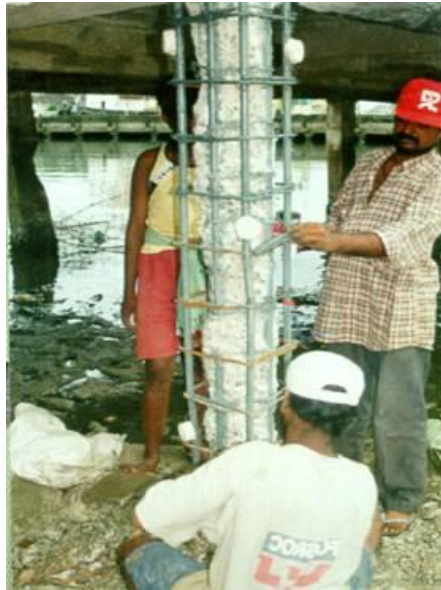
Fig. 7 Closer view of anodes installed

Based on the quantity of the steel provided, the required calculation was made for estimating the number of anodes to be provided. It was arrived to install 1 number per Sq. M surface area of the concrete in Case1 and 1 number per 0.75 Sq. M in Case 2. The connectivity was checked before and after installation of the self regulating sacrificial anodes. Leads were taken from the steel and also from the sacrificial anodes to the junction boxes, which were fixed on the surface of the micro concrete, so that the readings can be taken when required. Fig. 8 shows the typical view of the corrosion monitoring box.

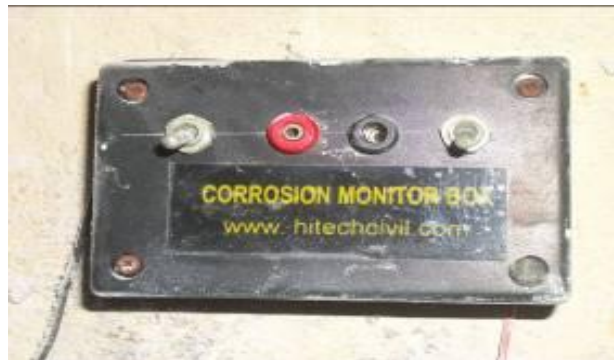
Fig. 8 Typical view of corrosion monitoring box.

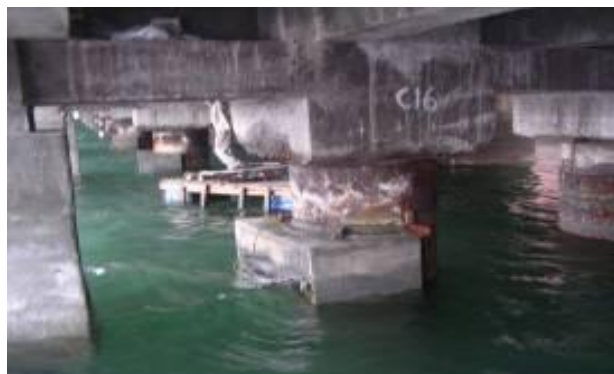
The members below water level were jacketed with under water micro concrete, which has anti wash & non-shrink properties. Above the water level, non-shrink free flow micro concrete was used. Both were grades of M45. As the thickness of the section to be jacketed was large, 12 mm downgraded aggregates were added at the rate of 1:1 by weight of the ready to use under-water/micro concrete. Fig. 9 shows the typical view of under-water/micro concrete and regular micro concrete done for the rehabilitated members.

Fig. 9 Typical view of rehabilitated members

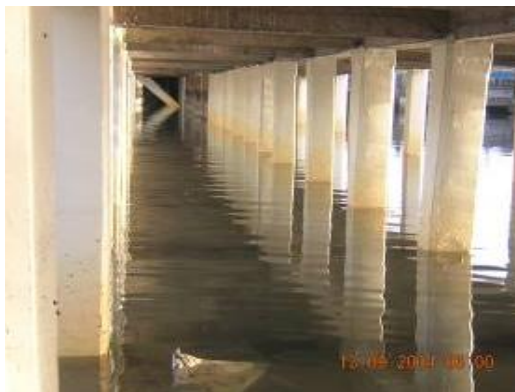
The surface areas of the members which are above the water levels were applied with acrylic based curing compound immediately after the stripping of formwork. After completion of all the works, the exposed jacketed surface was coated with silane/silaxone based primer, which can prevent the ingress of chloride ions and then coated with two coats of acrylic aliphatic based protective coating to prevent the carbonation in addition to addition to UV stability. Fig. 10 shows the typical view of protective coating done on the micro concreted members in the case study 2.

Fig. 10 Typical view of the protective coating

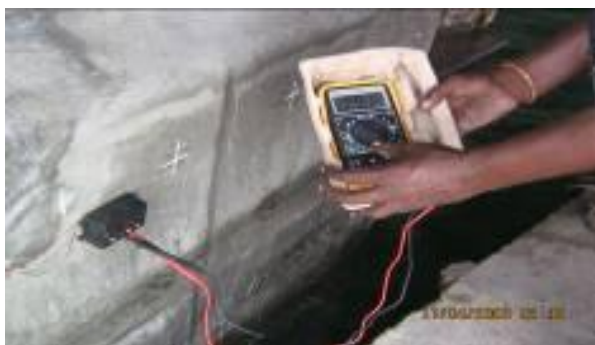
In the case of case study 1, after the completion of rehabilitation of Chockani Finger Jetty in the main land half cell potential measurements were conducted on the pile immediately after the completion of the repair & rehabilitation, and after 6, 12, 18 months from the time of completion of the rehabilitation. In the case of case study 2, after the completion of rehabilitation of Fisheries jetty approach in Andaman & Nichobar Island half cell potential measurements were conducted on the pile immediately after the completion of the repair & rehabilitation after one year. Fig. 11 shows the view of the half cell potential test in progress after the rehabilitation. Care was taken to ensure that the same locations before repair were again subjected to half cell potential test to assess the efficiency of the self regulating galvanic anodes.

Fig. 11 Typical view of half cell measurement after rehabilitation
