A Case History of Microtunneling through a Very Soft Soil Condition

the Contractor's Perspective

Abstract- Waikiki Public Bath Force Main Replacement Project consists of 1,037 m of 400 mm force main that carries the wastewater from the Public Bath pump station to a gravity sewer on the Kuhio Avenue. This force main transports wastewater underneath Kalakaua Ave, very close to some of the most expensive real state in the world. This area is the heart of Waikiki beach, and it is full of beach resorts, five star hotels, shopping, etc. The soil strata can be described as 2.50 to 3.00 m deep of beach sand on top of half a meter of a very hard coral ledge on top of a lagoon deposit layer (very soft gray fat clay). The N_{SPT} values in this lagoon deposit layer range from zero to eight. The specified construction method for this project was microtunneling of 700 mm of Permalok steel casing with a 400 mm PVC carrier pipe inside the casing. The annular space between the two pipes was grouted with low density grout. Many problems were encountered during the construction phase of this project. This paper is a retrospective review of the project from the contractor's point of view. It covers

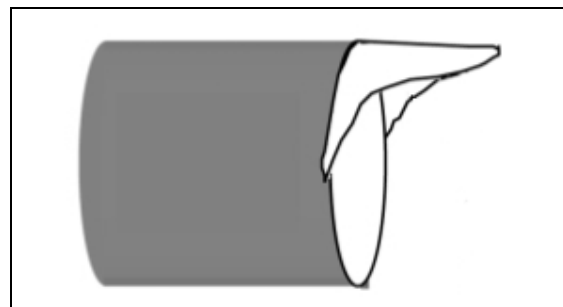
Figure 2 The barrel, hood, or plates ^[6]

A. Arched barrel, hood, or plates (as shown in Figure 2) would increase the bearing area of the MTBM and redistribute the concentrated load at the front of the head. This solution was eliminated because the cutters would not have access to tunnel through the potentially harder material along the drive and through the receiving shaft wall. If the barrel, hood, or plate could extend and retract upon demand, this solution might have been a better solution.

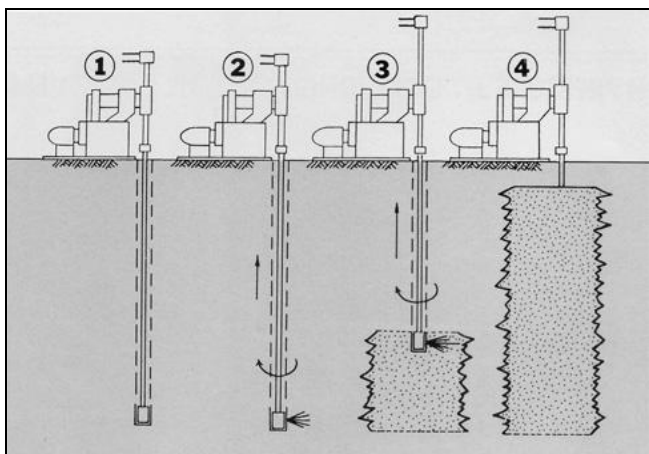
Figure 6 Jet Grouting procedures^[10]

F. Jet grouting pillar supports would create a total support for the pipeline by grouting pillars to the stronger coral ledge layer that lays 6.00 to 9.00 m below the pipeline invert. The pillars would support the saddles similar to those of compaction grout saddles in solution D or continuous block similar that of solution E. The jet-grouting-subcontractor's quotation was about a \$1,000,000.

This solution was the most reliable solution; it had successful history in similar conditions. The disadvantages of this solution were high cost, limited number of suppliers, and a long waiting time to procure a contract and to transport the required equipment to Oahu. In addition, there was a risk of over spilling on the streets and sidewalks, which was not acceptable in Waikiki.
