Why Was It So Damaging?

The Lorca Earthquake, 2011 May 11th

Atonio D. Aretxabala¹, Cristina L. Sanz²

¹Building Department, School of Architecture, University of Navarre

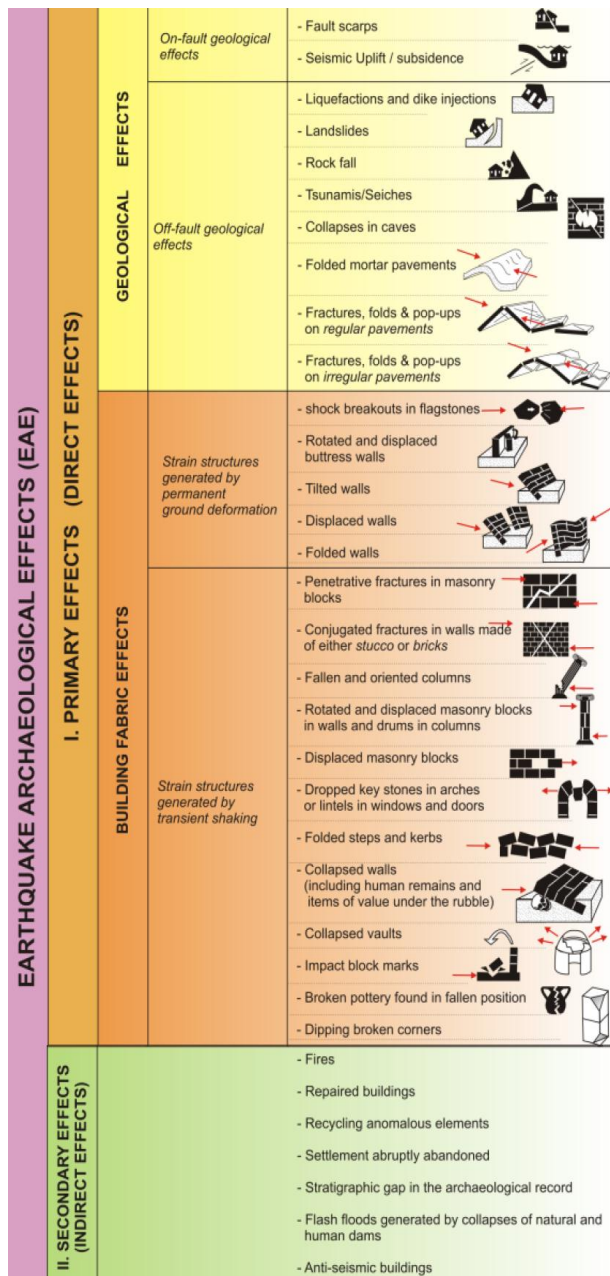
Fig. 3 Earthquake Archaeological Effects (EAE) Rodriguez-Pascua et al. (2011)

Structural geology techniques were used in the study of the historical building damage included in the IGME Report. More than a hundred effects were identified and classified in 33 masonry structural buildings, according to what Giner-Robles et al. (2009) and Rodriguez-Pascua et al. (2011) defined as Earthquake Archaeological Effects (EAE), depending on whether they are direct or indirect effects (Fig. 3). After analysing the global damage extent, the provisional budget was 50 millions €. Final figure, according to the Framework Plan for the Lorca's Cultural Heritage Recovery, drafted in July 2011, is 51,287,076.93 €. Complete restoration is scheduled to be completed in five years, if funds are available; too long taking into account the importance of tourism in Lorca's economy.

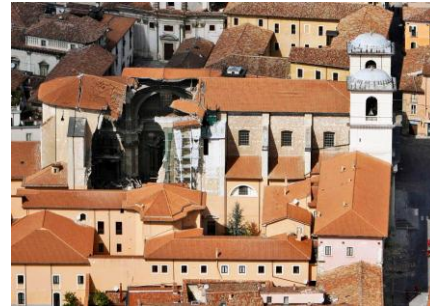
- **Santo Domingo Ensemble (XVIIth-XVIIIth c.).** In the Main Street of Lorca, comprise the convent or church and the Rosario Chapel. Only three cloister façades remained standing.

Final budget: 2,727,256 €. Under restoration.

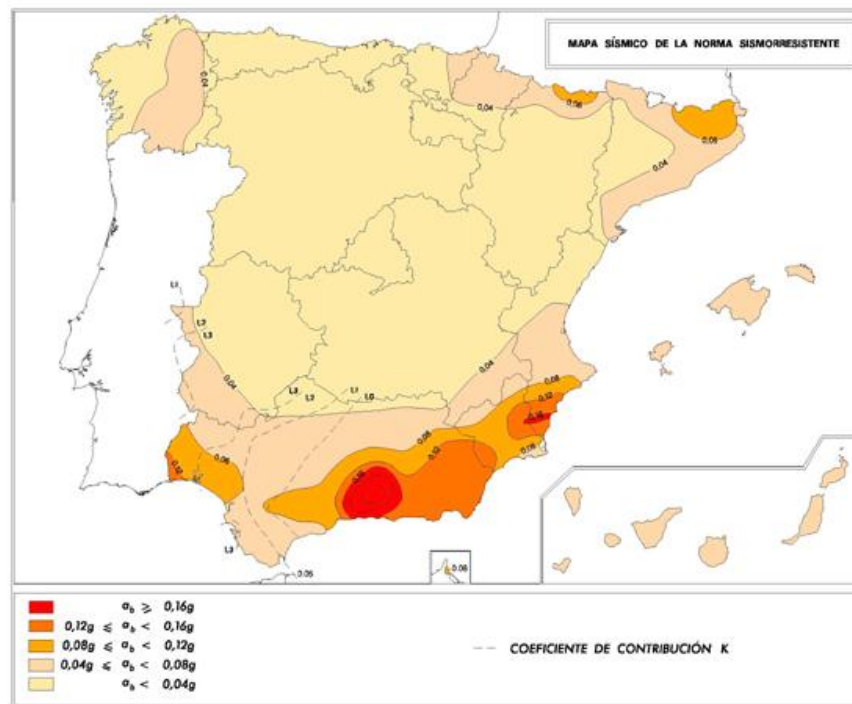
Fig. 19 NCSE 02 seismic risk map

The NCSE 02 map establishes a macrozonification for the basic acceleration values a_b (Fig. 19), the basis to obtain the design seismic acceleration, fundamental data required to design any seismic-resistant structure. The basic acceleration for Lorca is 0.12g. Granada and Alicante areas have values over 0.16g, being the highest 0.24g in the town of Santa Fe, in Granada. However, the most harmful recent seismic movements in Spain have been located in Murcia, which suffered five important seisms in the last 12 years: Mula (1999), Bullas (2002) y La Peca (2005, magnitude 4.4 Mw, 40 km away from Lorca) and the last one in Lorca (2011), all of them related to the FAM.

The seismic design acceleration resultant in Lorca, multiplying the basic by the rest of parameters to consider (four coefficients: contribution $k = 1.00$, ground type $C = 1.60$, risk $= 1.00$ and ground amplification, $S = 1.27$) is 0.15g, clearly minor than the maximum acceleration registered, 0.41g. The fact that the hypocentre was so superficial and the epicentre so close to the town centre were crucial for the disaster. The crust structure of the ground in Murcia, like in the rest of the SE of Spain, is similar to an assembly of domino pieces horizontally laid: when one of them moves, all the others are affected.

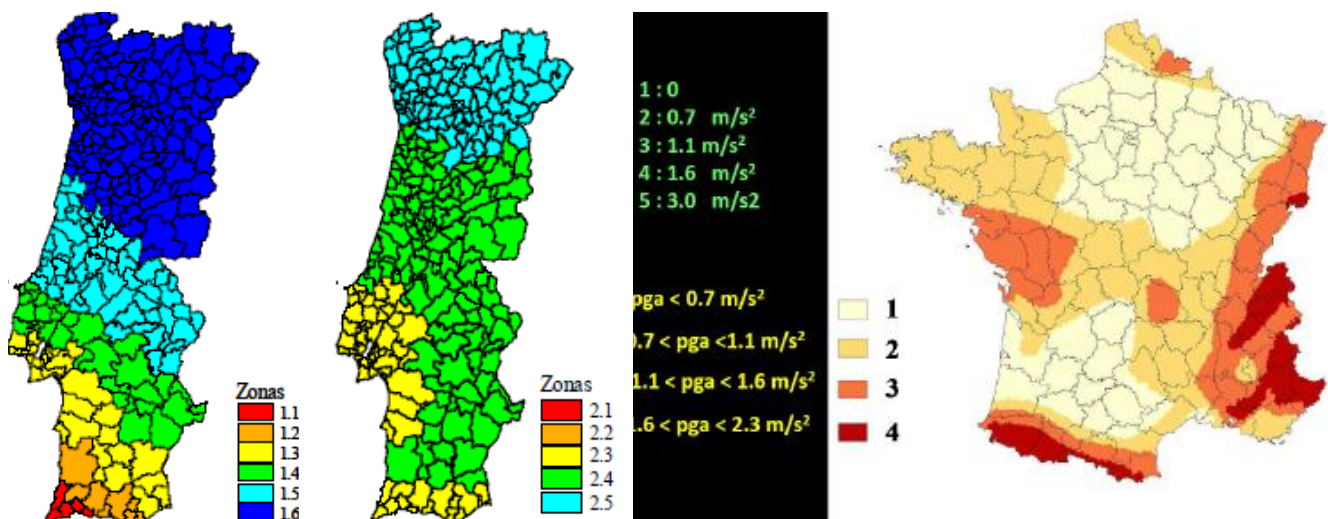
Fig. 20 Eurocode 8, Part 1. Risk maps of the nads of Portugal (above) and France (under)

This report includes the NCSE 02 map, highlighting the urgent need to modify its content in order to adapt basic seismic acceleration values to the maps of other countries around Spain, specifically in border areas like the Pyrenees (Fig. 20), with the values on the other side of the border being considerably higher.
