Temporary Strengthening Technique of Marble Columns with Steel Wires and Wood Spars

Keywords- Marble Column; Steel Collars; Compression; Cracked Columns; Strengthening

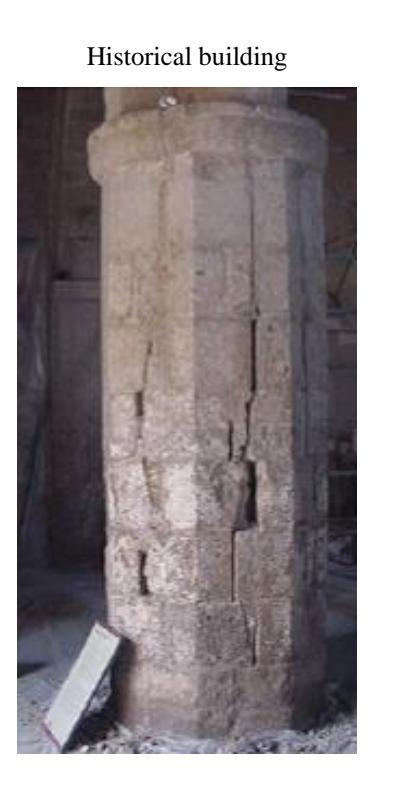
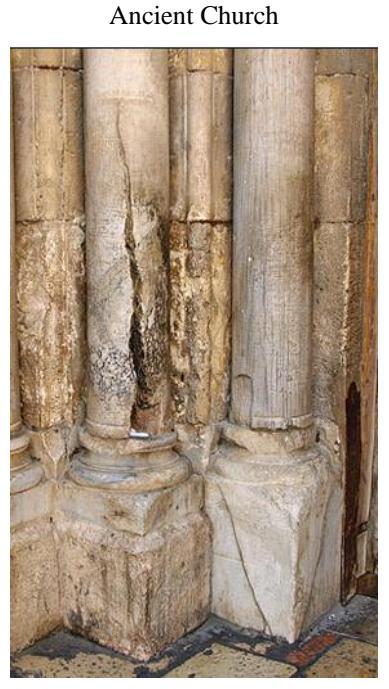
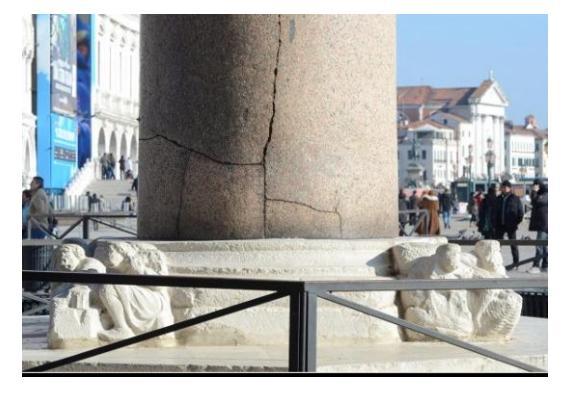
Fig. 2 Examples of cracked columns

In most of the cases of historical buildings shown in Fig. 1, columns have large cross-section if compared with acting loads, which produce low stresses very far from the compressive strength of material. Also, the slenderness ratios are very low and the risks of buckling failure are excluded. However, if columns are cracked the slenderness ratios increase significantly and the risk of buckling failure arises. Typical cases of columns damaged and cracked along the height of the member are shown in Fig. 2.

Examples of cracked granite or marble columns

Pantheon in Rome (Italy)

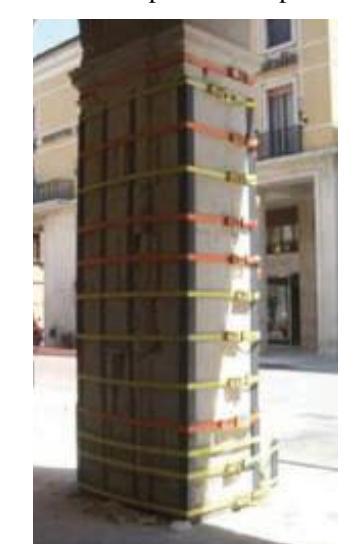
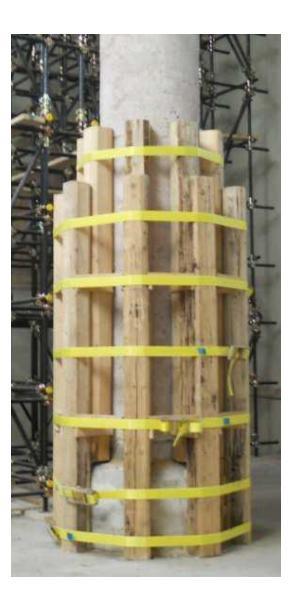
Fig. 3 Temporary Strengthening techniques

In these cases the collaring technique can be applied in order to strengthen the column. Examples of this technique are shown in Fig. 3, referring to temporary post-emergency methods adopted by the Italian Civil Protection and firemen during the recent severe earthquakes happened in Italy (L'Aquila 2009 and Emilia Romagna 2012). More in detail the technique consists in providing wood spars in the direction of the column axis, which have to be linked together by wrapping them with metallic or polymeric strips. Even if the application of this technique resulted as an invasive technique, especially for the external visual impact, it represents a good and cheap solution to strengthen columns as a provisional solution before the final retrofitting of the columns with adequate techniques [6, 7].

Wood spars and strips

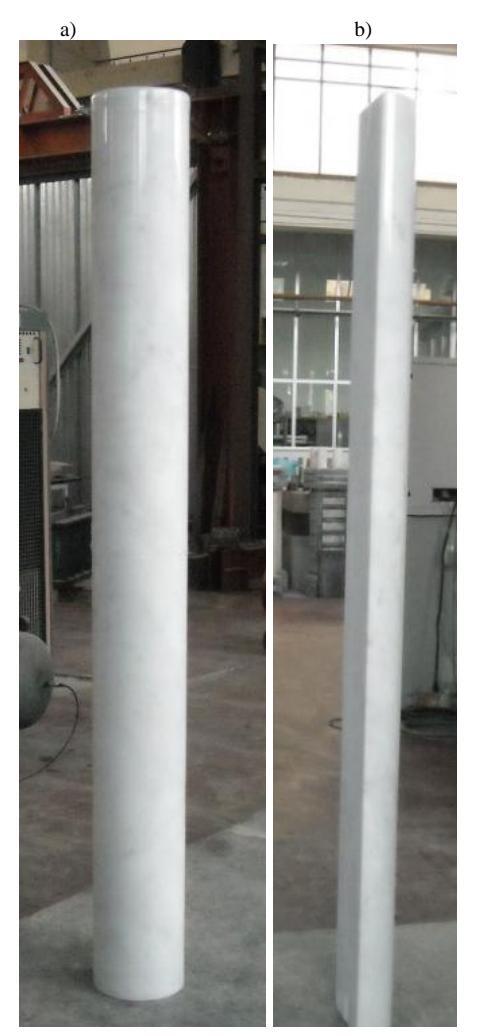
Fig. 4 shows monolithic column and half column, the latter to be utilised to make up a single member constituted by two half pieces.

Fig. 4 Marble columns a) monolithic; b) half column

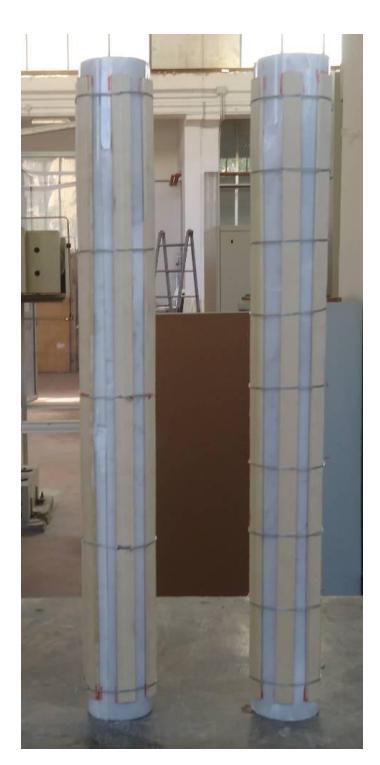
Eight wood spars were disposed longitudinally along the column and in polar-symmetrical position with respect to the centre of the specimen. The spars had thickness of 5 mm, width of 20 mm and height of 750 mm. Two steel stainless wires (see Fig. 5) having diameter of 0.5 mm composed each single steel collar. In particular, two specimens were reinforced with a pitch of 180 mm (steel collar 1) while the other specimen couple the adopted pitch was 90 mm (steel collar 2). Although the steel type used is an important issue to ensure durable bond between the steel and marble, in this paper the focus was on the use of stainless steel wires for temporary retrofitting of cracked marble columns and for this reason this aspect was not taken into account.

Fig. 5 Two half marble columns reinforced with the steel collaring technique

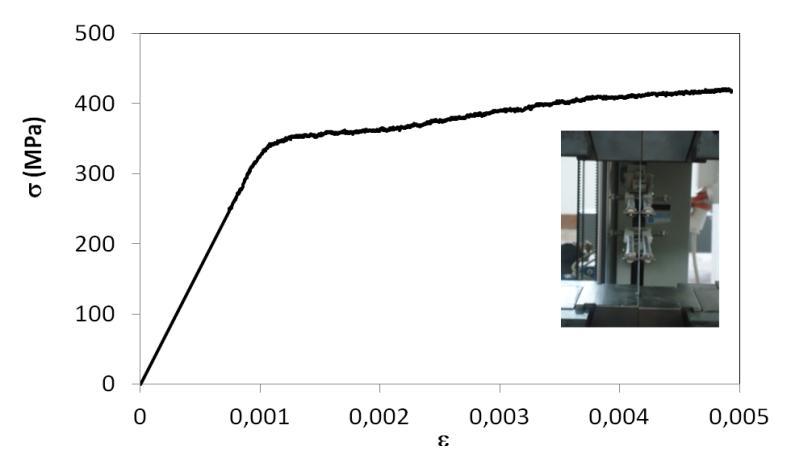
The wires were made up with stainless steel and monotonic tensile tests were undertaken on both one and two coupled wires in order to characterize their mechanical properties. Table 2 summarizes the results of the tests in terms of yield f_y and ultimate f_u tensile stress, while Fig. 6 shows the obtained average stress-strain curve. The modulus of elasticity measured on steel wire was 203000 MPa.

Fig. 6 Stress-strain curve of stainless steel composing the wires

Tying of steel wires was made manually simply by fixing them by hand with a pincer and without adopting particular details (Fig. 6). Both the wires and the tightening nodes remained safe after all the undertaken tests. Wood spar specimens had weight density of 500 daN/m^3 and modulus of elasticity in compression of 13500 MPa.

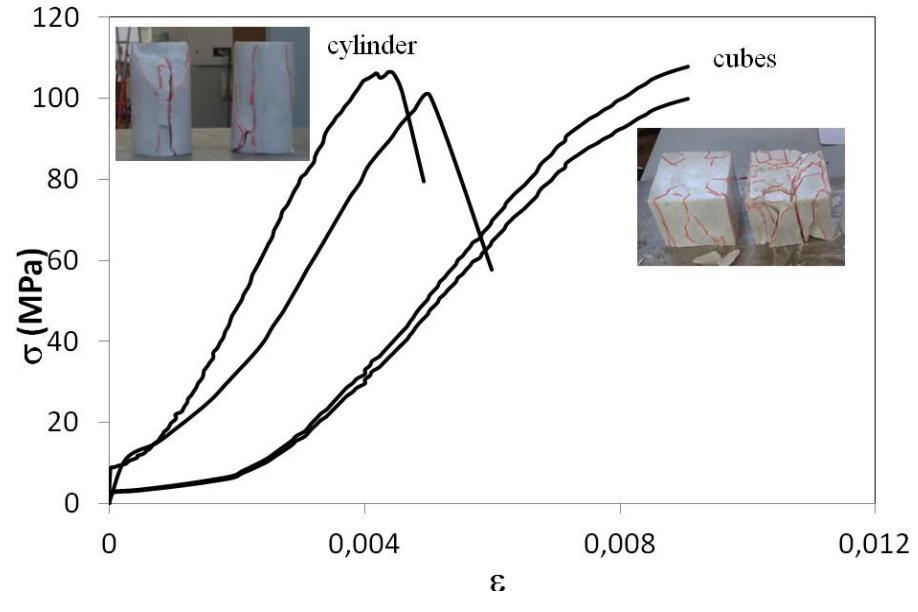
Fig. 7 shows the stress-strain curves deduced from the compressive tests on marble cylinders and cubes. Material behaves quasi-linear up to failure, excluding the initial non-linear phase due to the settlement of the testing machine. After the peak stress, the behaviour was characterized from a strongly brittle response. The failure mode of cubes and cylinders was characterized from a few of vertical cracks, coherently with the brittle material behaviour with high strength properties. The influence of shear stresses between the steel bearing plate of testing machine and the surface of marble specimens was negligible. Therefore, compressive strengths on cylinder and cubes were almost the same.

Fig. 7 Stress-strain curves of marble cylinders and cubes

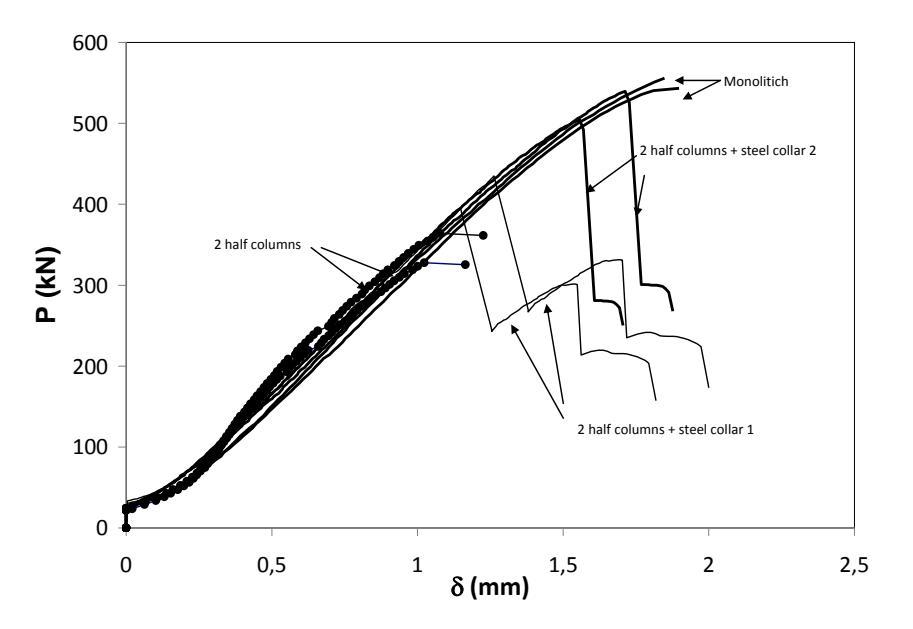
Fig. 8 reports the axial load-shortening curves of solid columns cracked artificially by means of a cut along the length of the columns producing columns in two equal halves. In the same figure the results relative to columns retrofitted with the steel collaring technique with the two adopted pitches are also represented. As can be noted, the strength of solid columns was similar to that deduced from compressive tests on cylinders, while the maximum stress of the "two half columns" was evidently lower, even if the gross area of the transverse cross sections was the same.

The maximum peak load of two half columns retrofitted with the above described technique increased up to a value lightly lower that that recorded in monolithic columns. In particular the specimens reinforced with a lower pitch exhibited greater strength values, while those having the more largely spaced collars had shown lower peak loads.

Fig. 8 Axial load-shortening curves of marble columns

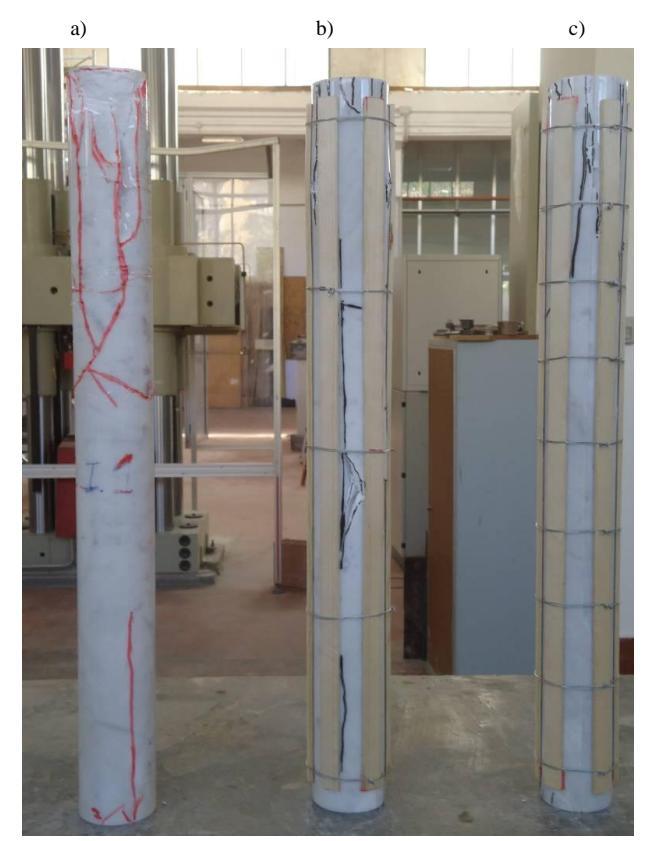
Fig. 9 shows the three specimens after testing. Failure of monolithic columns occurred due to compressive crushing of marble while for the two half columns the failure was due to buckling. Both the crushing and buckling occurred in reinforced columns, while crushing is more prominent in specimens having collars spaced with smaller pitches. After testing, the reinforced columns had fewer cracks than the unreinforced cut specimens.

Fig. 9 Specimens after testing: a) monolithic; b) two half column with steel collaring type 1; c) two half column with steel collaring type 2

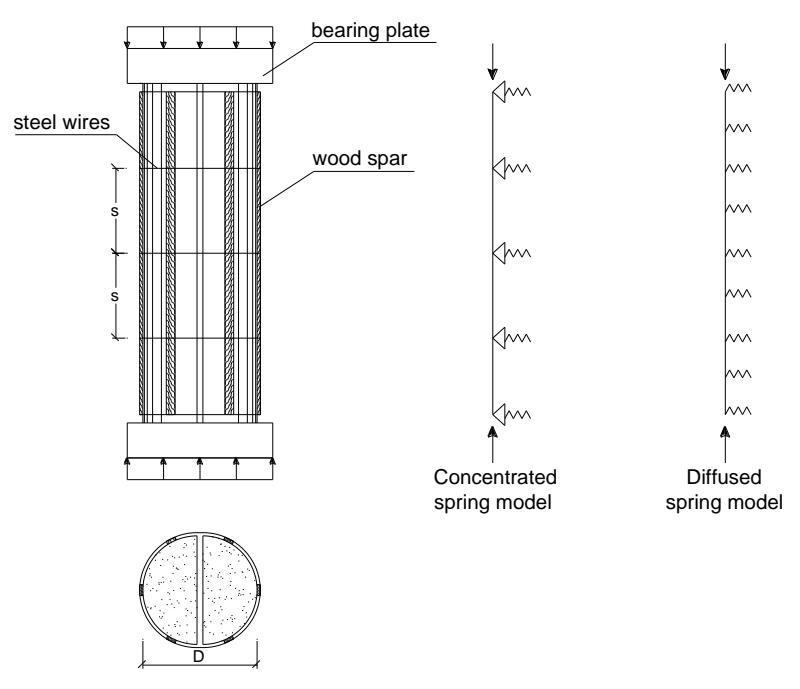
With reference to the buckling phenomenon, the critical load of slender columns was calculated with reference to the classic Euler's theory, while in the case of cracked columns with steel collaring the critical load was determined by considering a model of elastic beam on elastic soil, the latter simulating the effect of the steel collars is as described below and shown schematically in Fig. 10.

Fig. 10 Strengthened marble columns and theoretical model

In the case of steel collaring the critical load of the marble columns increases and it can be calculated in a simplified manner by distributing the stiffness of each single collar along the column's height. The case can be studied considering the model of an axially loaded half column on an elastic springs with stiffness parameter k.

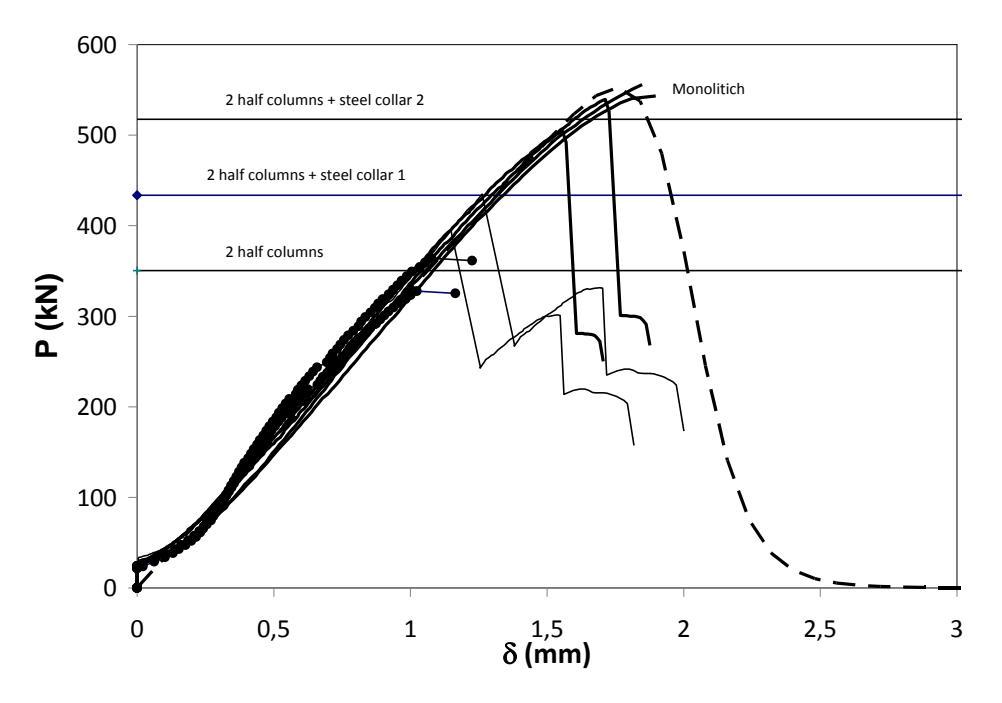
It has to be stressed that the axial stiffens of collaring should consider the coupled effect of steel wires and wood spars. But, for simplicity here, only the radial axial stiffness of annular sections constituted by steel wires was considered, as shown in Eq. (13). Fig. 11 shows the comparison between the experimental and the theoretical critical load, calculated as discussed above.

Fig. 11 Experimental and analytical prediction with the proposed model

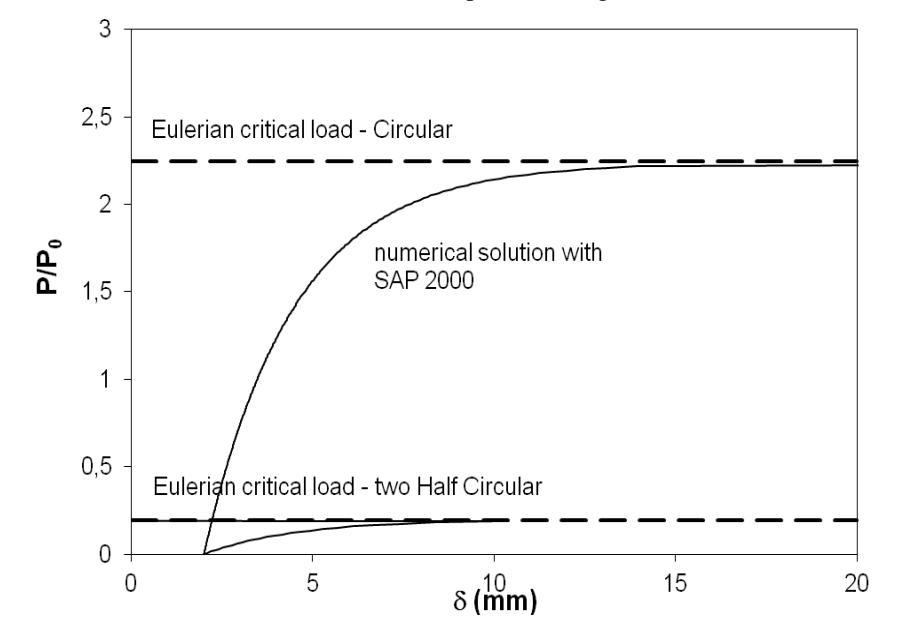
The global compressive behaviour was also deduced by adopting the constitutive law given in Eq. (1). In all the cases, the theoretical provisions resulted in good accordance with the experimental data, highlighting the efficiency of the adopted technique in recovering the monolithic condition of the cracked column. Theoretical load values are those indicated in Fig. 11 and indicated with the horizontal continues line, while for monolithic columns complete load shortening curves was that obtained with Eq. (1). The numerical analysis was carried out by using the SAP 2000 [8] program, examining a simple beam cantilever model the model. Cross sections in both cases of circle of half-circle were modelled by using square strip elements. Non-linear compressive behaviour described by Eq. (1) was adopted. For tensile behaviour of marble stone, a linear behaviour was assumed and a maximum stress value was considered equal to 1/10 of the compressive strength. Both moduli of elasticity in compression and in tension were assumed 41750 MPa, in agreement with the expression given in Campione (2010). The variation of normalized axial load versus horizontal deflection is plotted in Fig. 12.

Fig. 12 Numerical solution with SAP 2000 for variation of critical load with lateral deflection

Load was normalized to compressive strength of un-cracked column. Also, theoretical values deduced by Eulerian approach are given. The numerical results are in agreement with the predicated values by Eulerian theory and the experimental values.
